# KC1 Fault Card

**Edition: September 2012, Revision A**

Part Number 903-400002-00

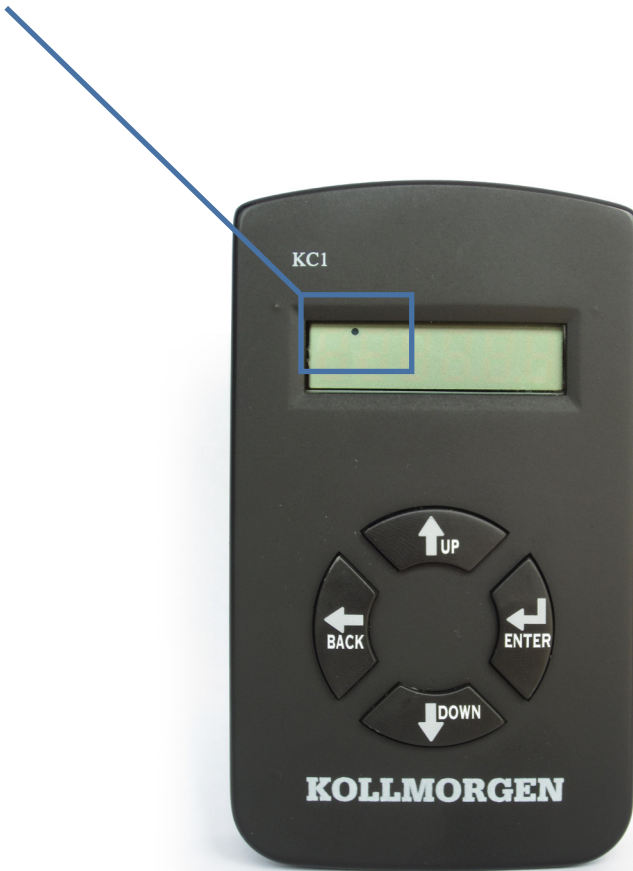
The dot located on the pendant's LCD displays the status of the EtherNet connection between the pendant and the drive. When flashing this indicates the connection is in progress and when solid this indicates the connection is successful.
