KC1 Fault Card

Edition: January 2013, Revision B

Part Number 903-400002-00

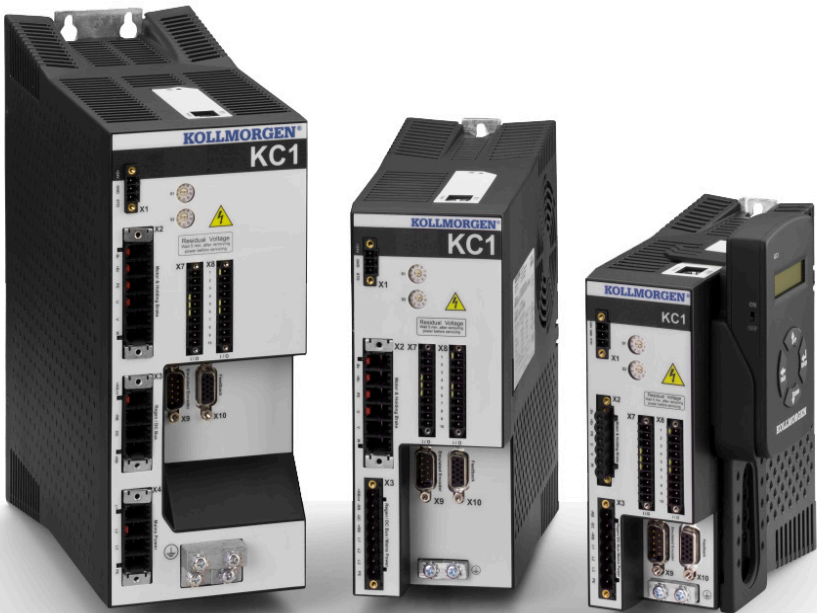
The left side of the LED displays **F** for a fault or **N** for a warning. The right side displays the fault or warning number as follows: 1-0-1-[break]. The highest priority fault is displayed on the LED, but multiple faults may be present when a fault condition is occurring. Check the KC1 WorkBench **Fault** screen or read the status of DRV.FAULTS through the controller or HMI for the entire list of faults.

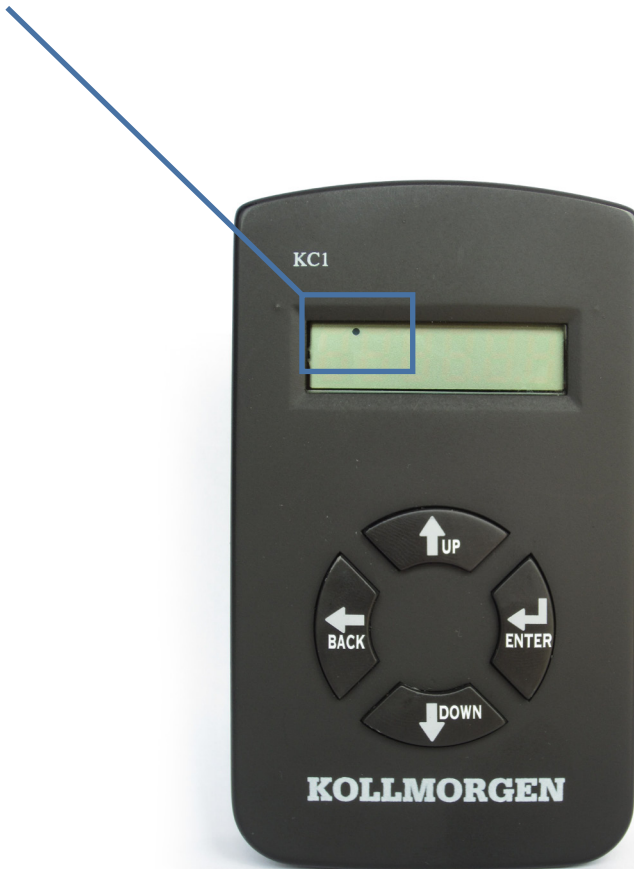
2. KC1 Pendant Faults (Optional)

The dot located on the pendant's LCD displays the status of the EtherNet connection between the pendant and the drive. When flashing this indicates the connection is in progress and when solid this indicates the connection is successful.

Fault	Message/Warning	Cause	Remedy
F01	EtherNet connection error.	Cable is loose or disconnected.	Check cable and verify it is properly connected.
