KC1 Fault Card

Edition: April 2015, Revision C
Valid for Hardware Revision B
Part Number 903-40002-00

1. KC1 Fault and Warning Messages

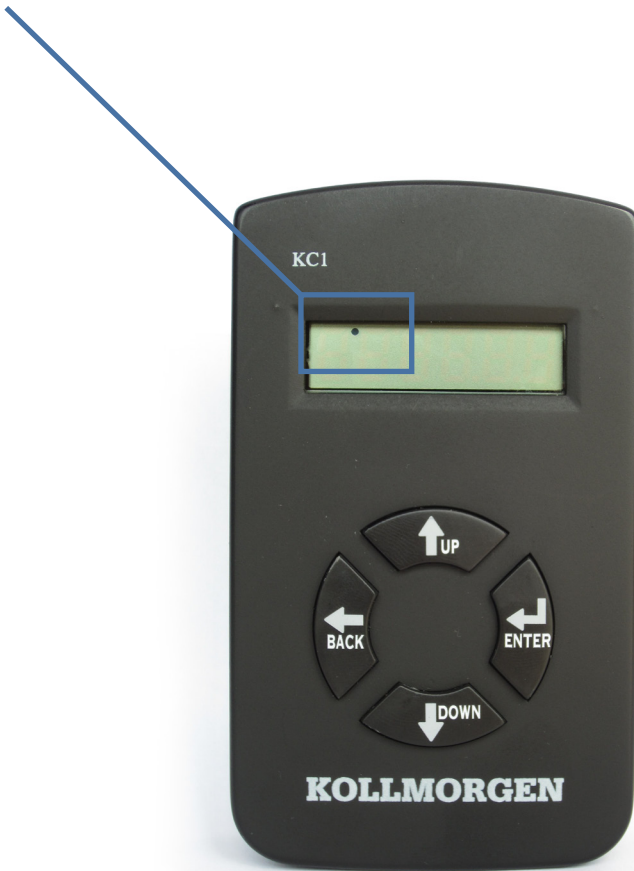
The dot located on the pendant's LCD displays the status of the EtherNet connection between the pendant and the drive. When flashing this indicates the connection is in progress and when solid this indicates the connection is successful.
